Estabrook Dam Stop Log Section and components

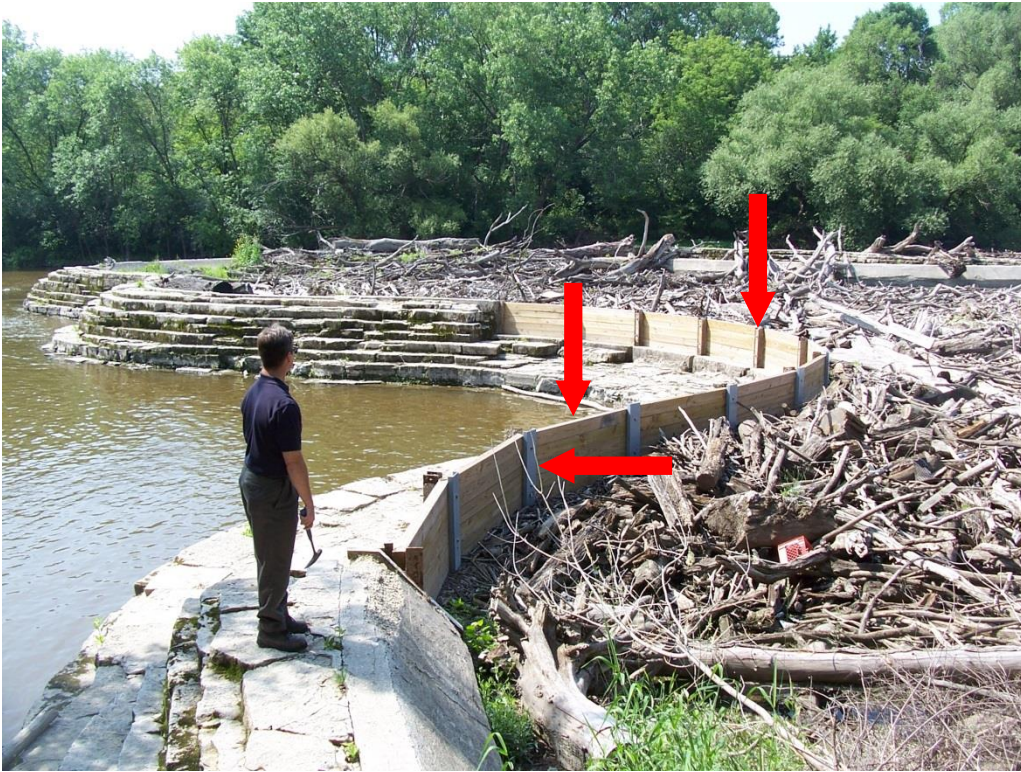
Photo 1: View of stop log section in June 2010 prior to being removed. Right arrow is pointing to typical stop log stanchion. Middle arrow is pointing to timber stop logs. Left arrow pointing at steel channel section of the stop logs.

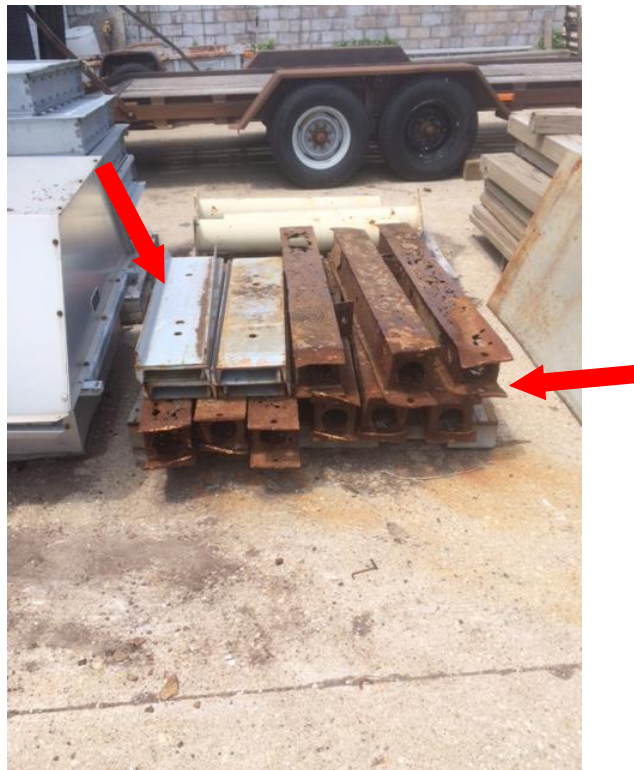
Photo 2: View of steel channels (left arrow) for the stop logs and severely corroded stop log stanchions (right arrow)
